Spatial FOG Dual Trimble MB-Two Firmware Upgrade Revision 3

This document outlines the steps involved in upgrading the firmware of the Trimble MB-Two GNSS receiver that is inside the Spatial FOG Dual. Please contact our Application Support Engineers if you have any questions about this procedure **before** you start: support@advancednavigation.com.

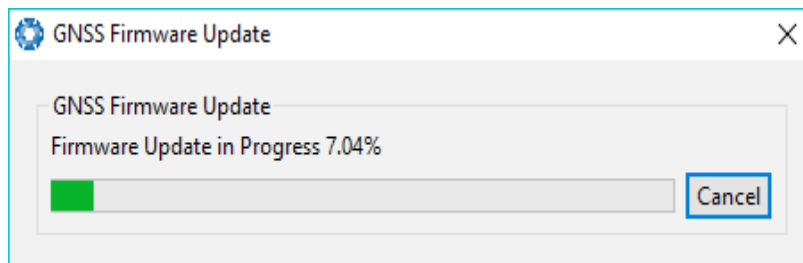
8. **Once the update starts do not stop it!** Wait for the update to complete. The duration will depend on the serial baud rate you are connecting at but it could be an hour or two. Once it is completed you need to wait another 2 to 3 minutes for the update to be applied internally. If the procedure appears to halt during the process, press Cancel, perform a power cycle on the Spatial FOG Dual and run through the procedure again from Step #7.
